July 8, 2019  
File No. 132473-003

Subject: Weekly Monitoring Report for Week Ending 06/29/2019  
Florence Copper, Production Test Facility  
Aquifer Protection Permit No. 106360, LTF 61845

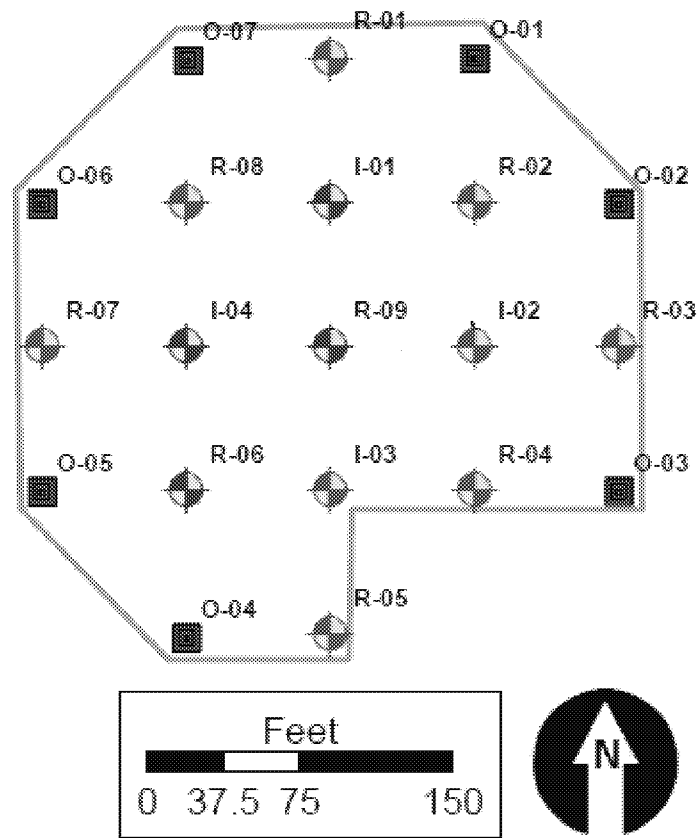
A map showing the location of the PTF injection, recovery, and observation wells is included as Figure 1.

Figure 1. PTF injection, recovery, and observation well locations

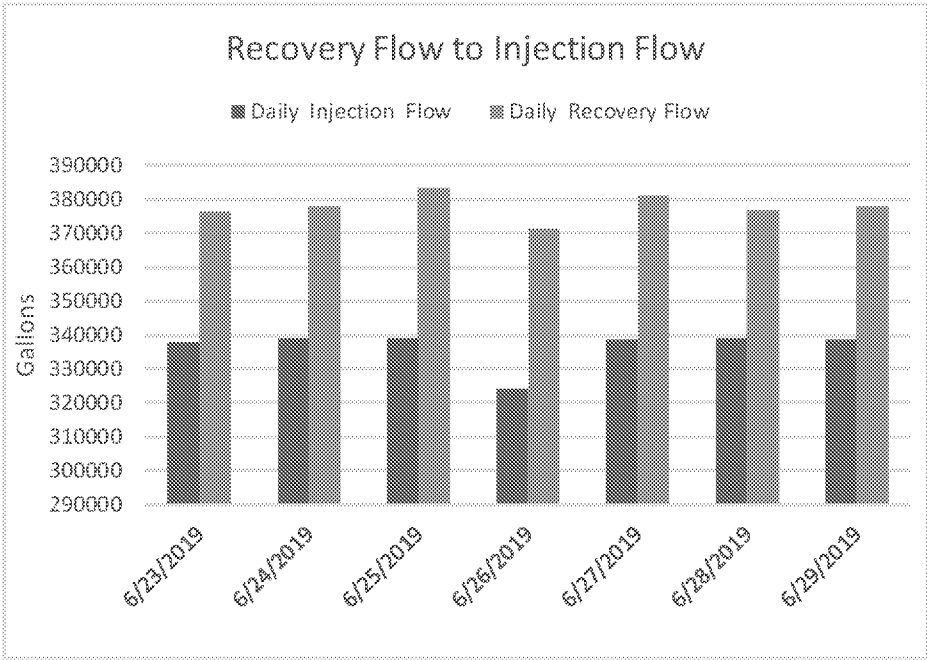
A summary of the injected and recovered volumes for the week 06/23/2019 to 06/29/2019 is included in Table 1. The total injected and recovered volumes for the PTF as a daily total are also presented on Figure 2.

During the reporting period no exceedance of the alert level was measured for recovered volume to injected volume. The alert level is the recovered volume shall exceed the injected volume.

Figure 2. Recovered volume to injected volume

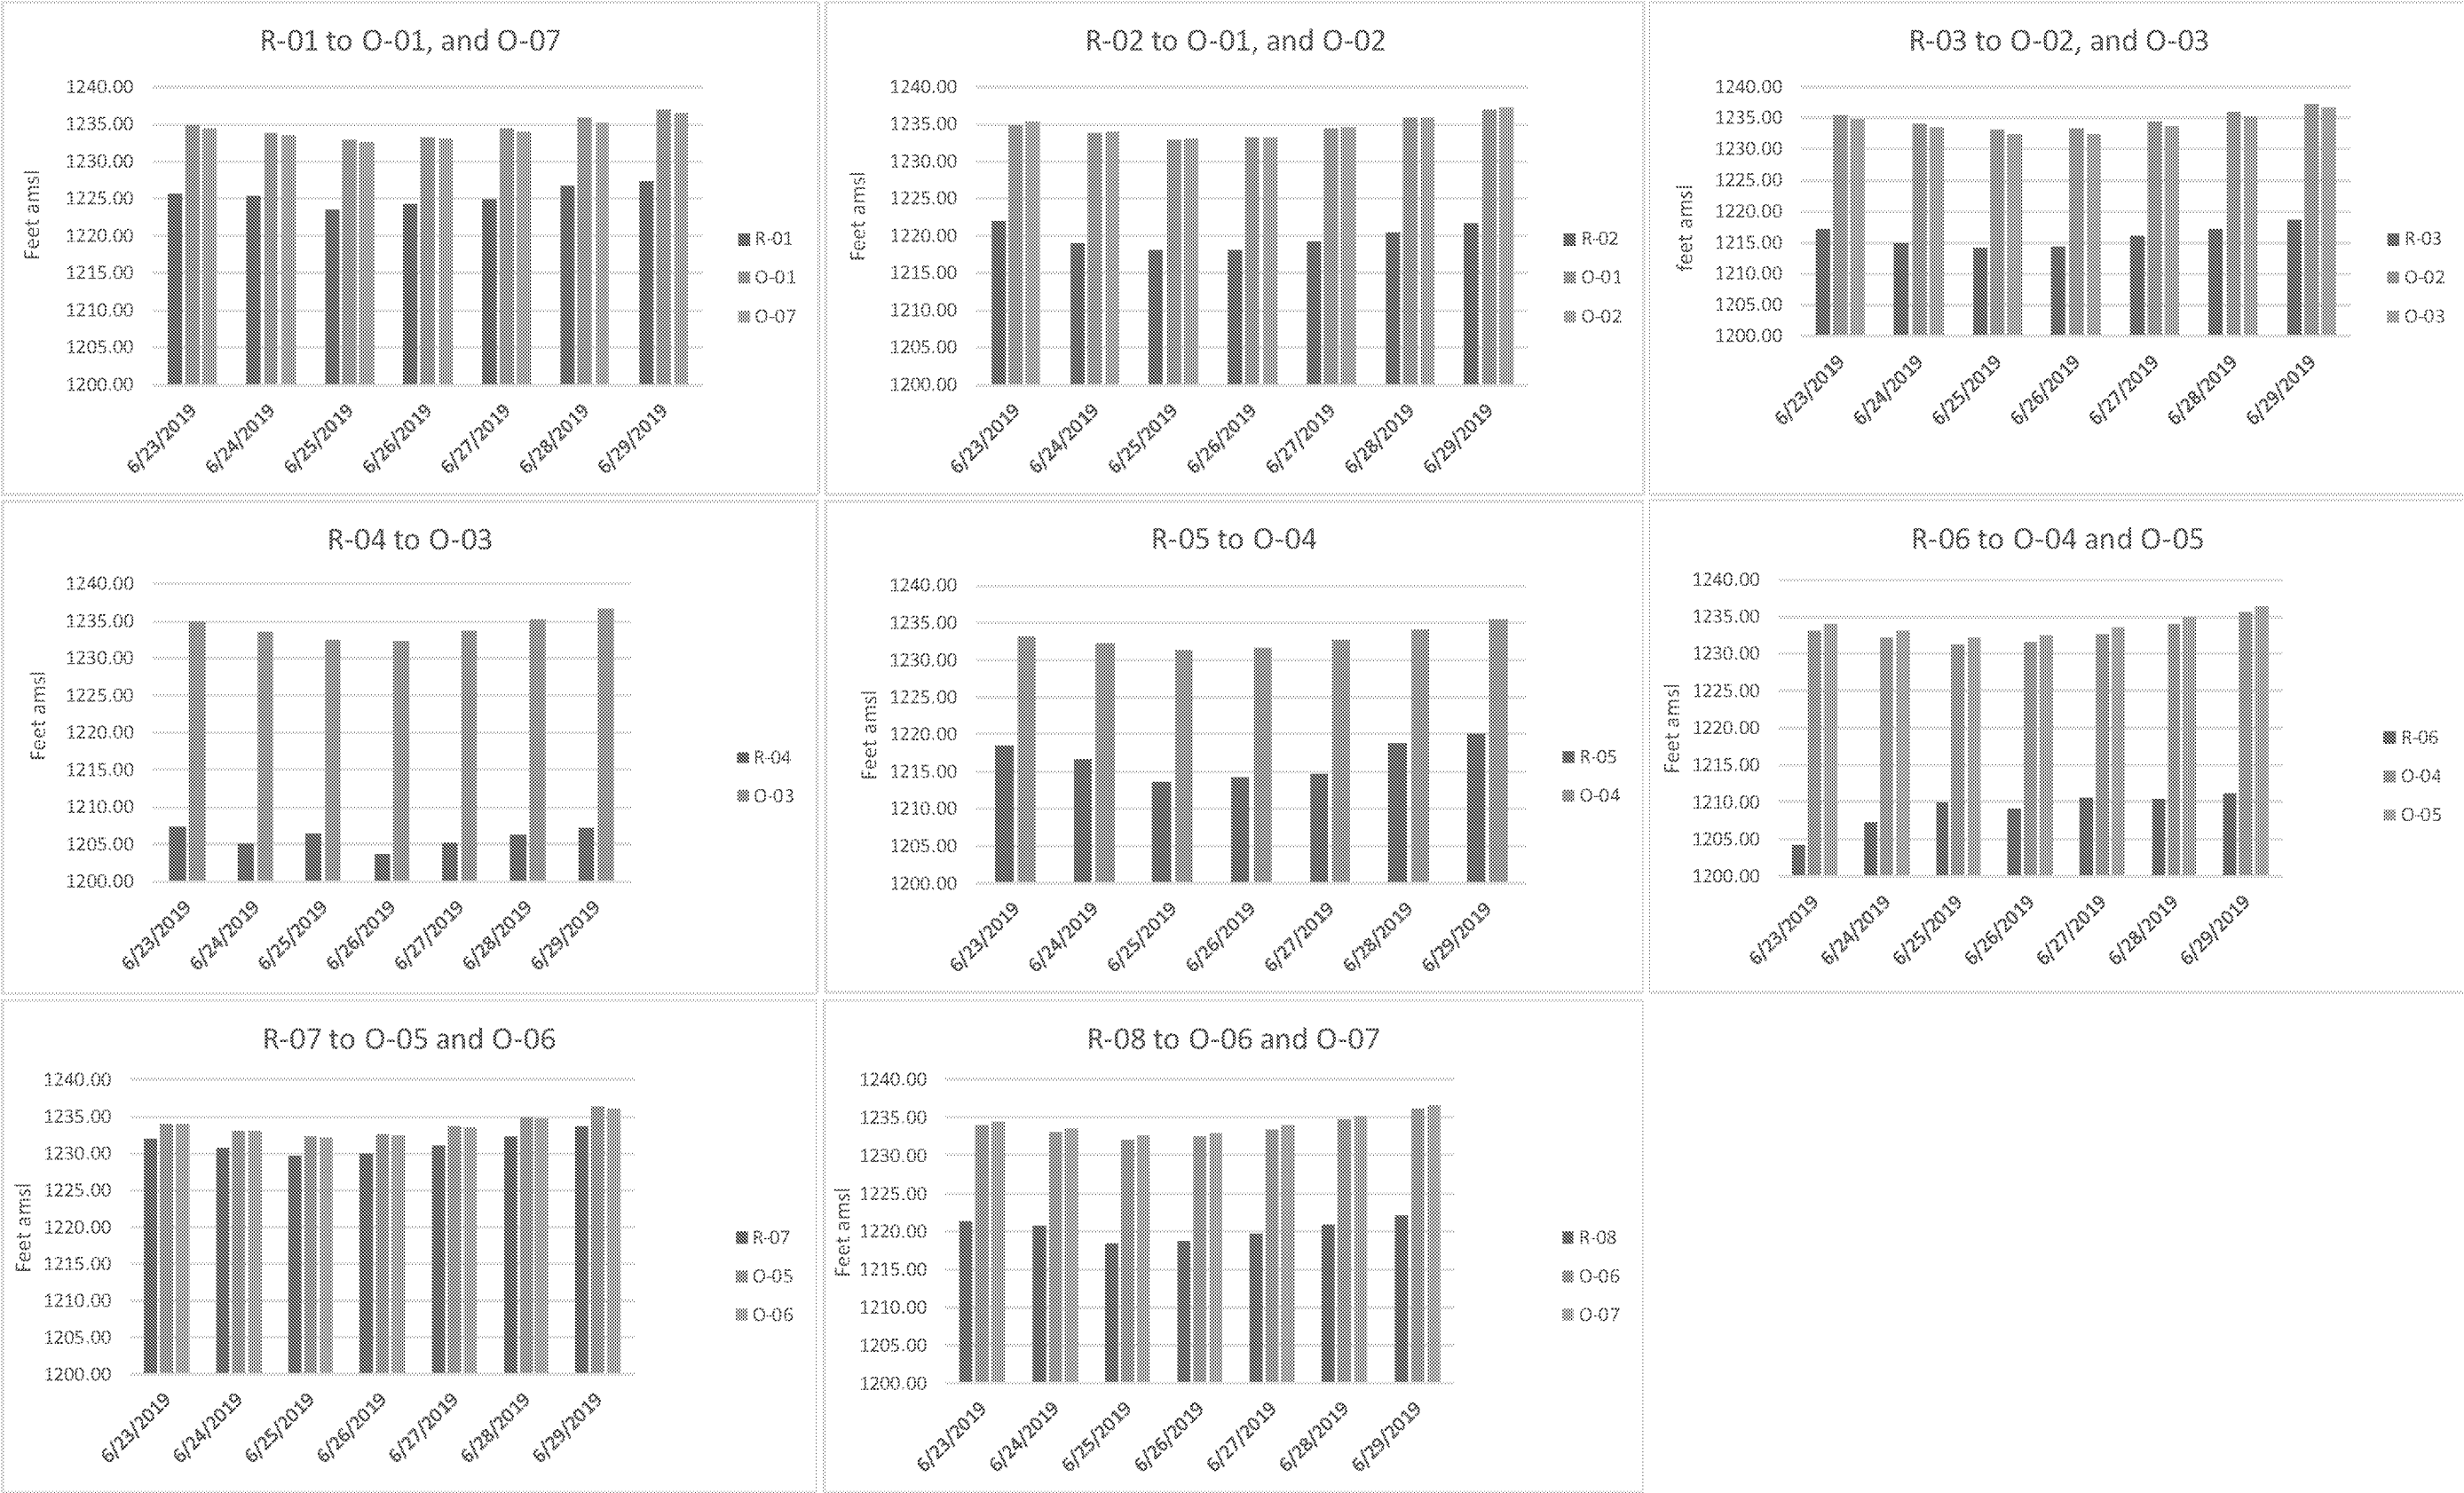
Figure 3

Table 2 includes a summary of water levels in the recovery and observation well pairs. Hydrographs showing the water level elevation for each recovery well and observation well pair are included in Figure 3.

During the reporting period, there was no exceedance of the alert level for the inward hydraulic gradient. The alert level for the inward hydraulic gradient is that the water level elevation in the paired observation well must be a minimum of 1 foot higher than the paired recovery well.

Figure 3. Recovery and observation well pairs
